Ground Improvement for Data Center Site Development

INDUSTRIAL/COMMERCIAL
DEVELOPMENT

IN-SITU COMPACTION

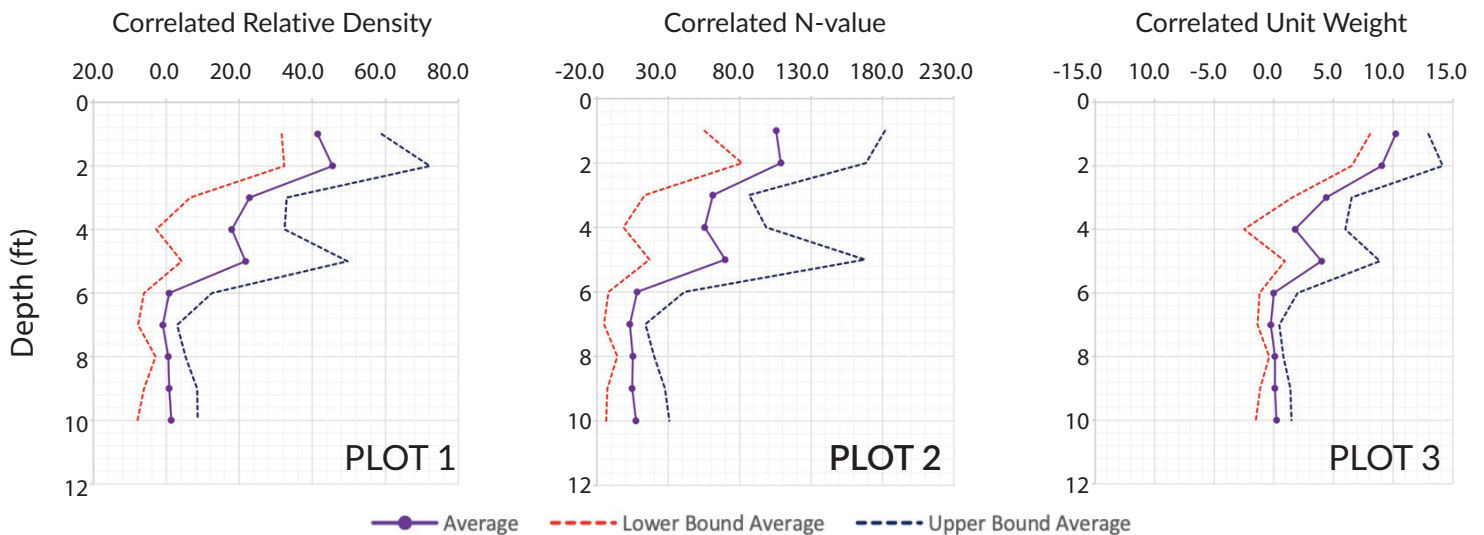
CPT 01, CPT 04, CPT 07 & CPT08 - Average Percentage Changes

Using established correlations, Langan calculated the average percent change in relative density, N-value, and unit weight at each depth from pre- and post-HEIC CPT data (CPT01, CPT04, CPT07, CPT08).

Results showed soils from the surface to ~5 feet were 20-45% more compact, had up to 180% higher N-values, and up to 14% higher unit weights. Below 5 feet, changes were minimal (0-9% more compact).

Plots 1 through 3 show that the soils closest to the surface were the most impacted by the HEIC treatment, with the effect gradually decreasing below roughly five feet.

Plot 1 indicates that from the surface to about five feet, soils became significantly more compact—on average 20% to 45% denser. Below five feet, the change was minimal, averaging between -1% and 1.3%.

Plot 2 shows that correlated N-values increased by about 55% to 110% in the upper five feet. Deeper soils saw smaller gains, ranging from roughly 3.1% to 8.2%.

Plot 3 reveals that unit weights rose by about 1.8% to 10.2% in the upper five feet. Below this depth, changes were negligible, from -0.3% to 0.2%. Overall, post-HEIC CPT data confirms that the upper five feet of the soil profile was densified, as reflected by notable increases in relative density, N-values, and unit weights. Below this depth, improvements were limited due to the soils already being relatively dense prior to treatment.

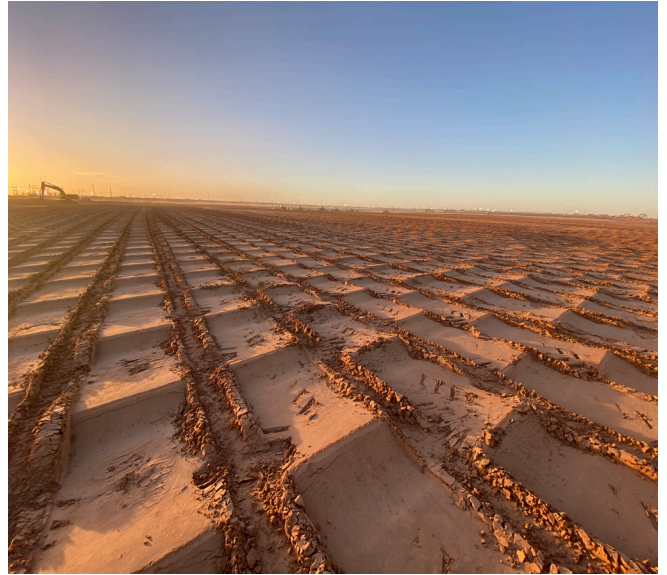
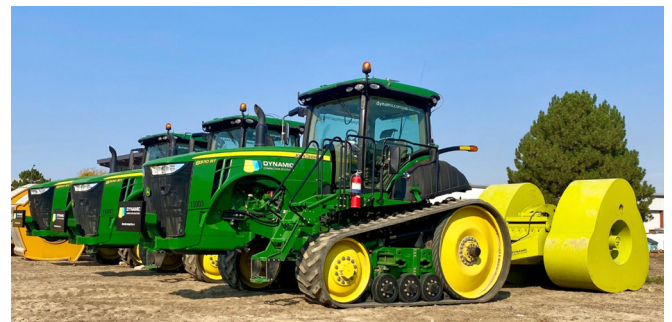
Plot 4 and DCS's measurements indicate that the HEIC induced approximately six inches of average ground settlement across the site.
